THE CALIFORNIA EARTHQUAKE OF APRIL 18, 1906

STATE EARTHQUAKE INVESTIGATION COMMISSION

IN TWO VOLUMES AND ATLAS

ANDREW C. LAWSON, CHAIRMAN

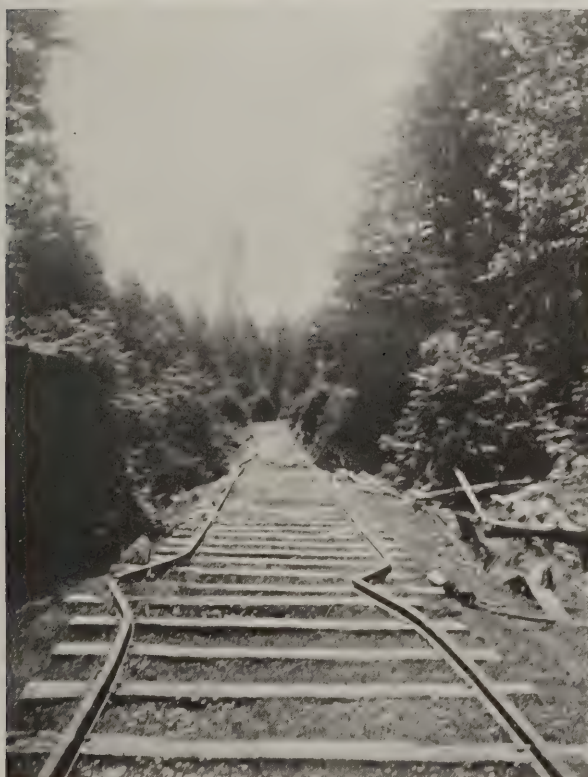
C. Buckled track, Little North Fork Gualala River. Both rails broken. Fault-trace parallels track 50 feet to left. F. E. M.

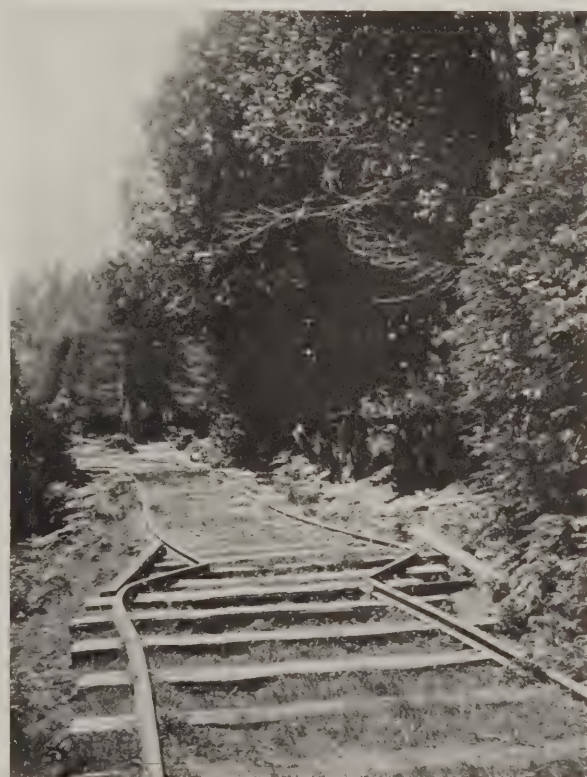
D. Buckled track, Little North Fork Gualala River. Fault-trace 100 feet to left. F. E. M.

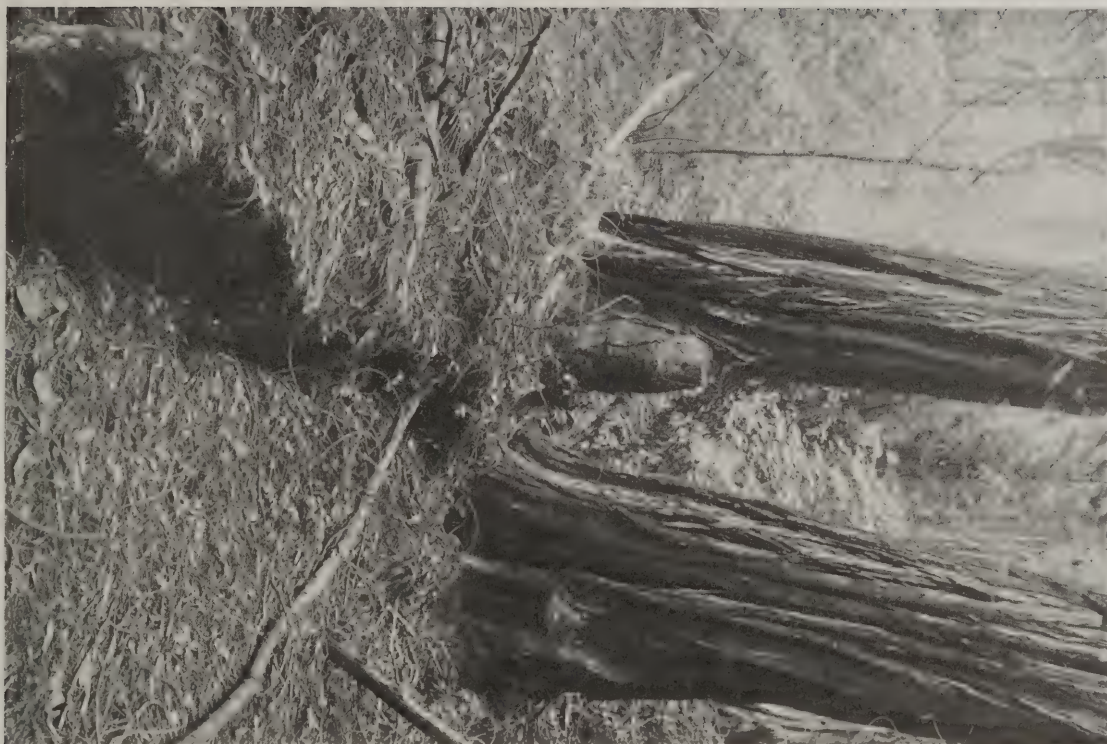
A. Fault-trace in redwood forest near Fort Ross, J. N. L.

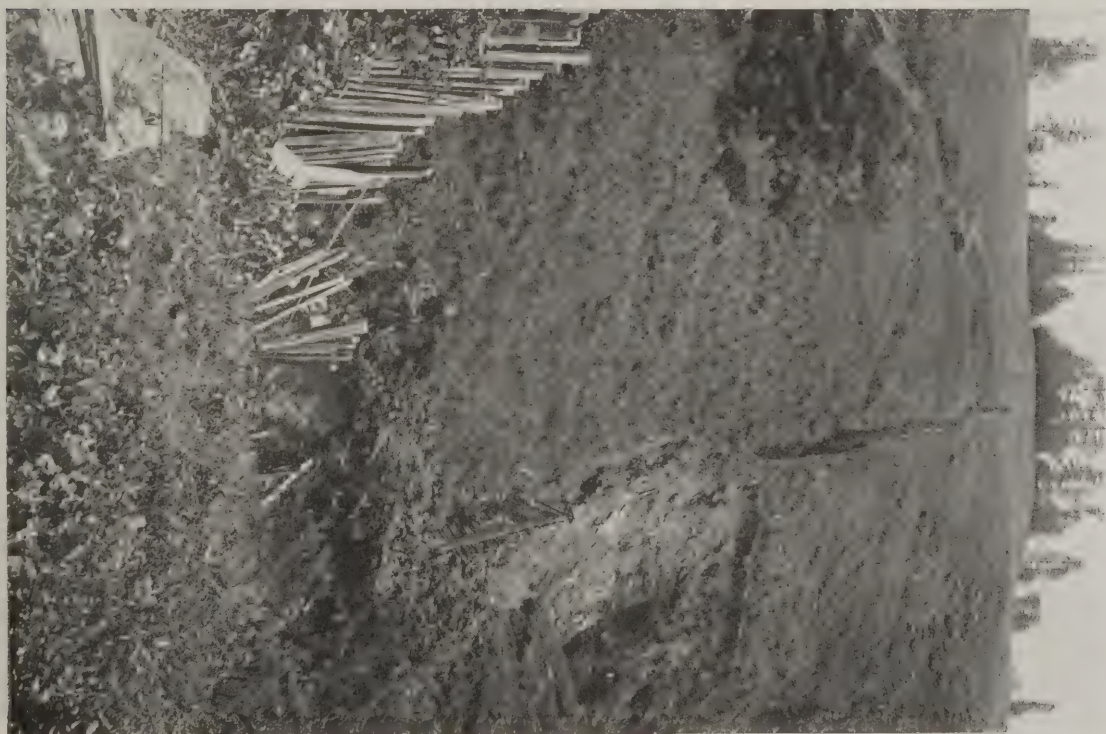
B. Dislocation of fence near Fort Ross, J. N. L.

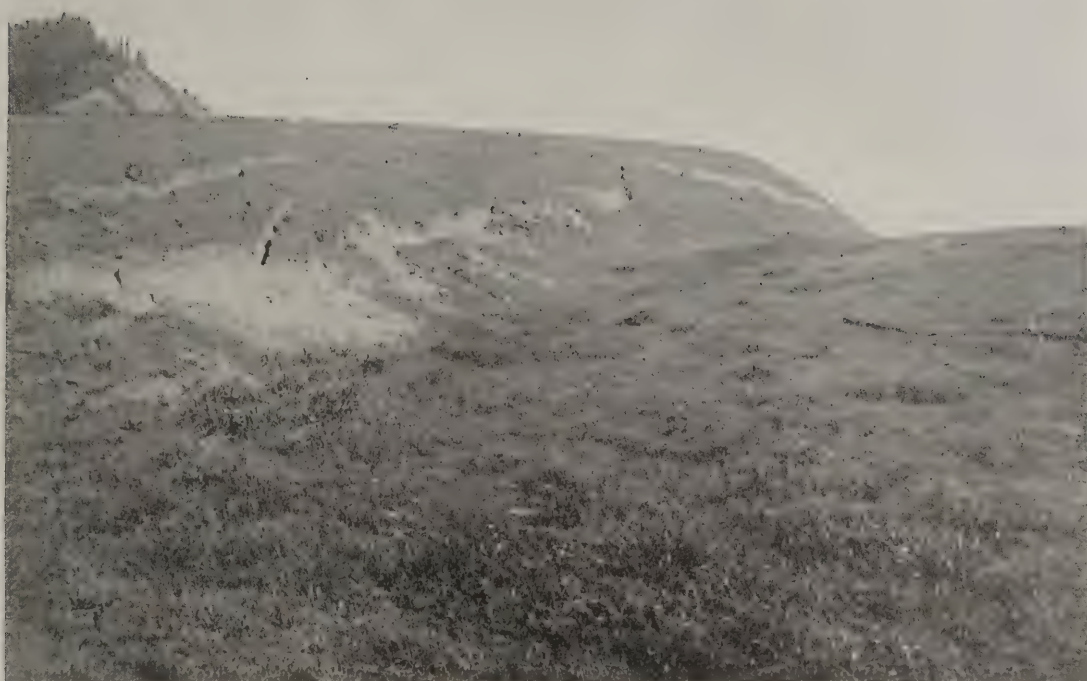
A. Accentuation of old scarp by new fault 1.5 miles north of Fort Ross. J. N. L.

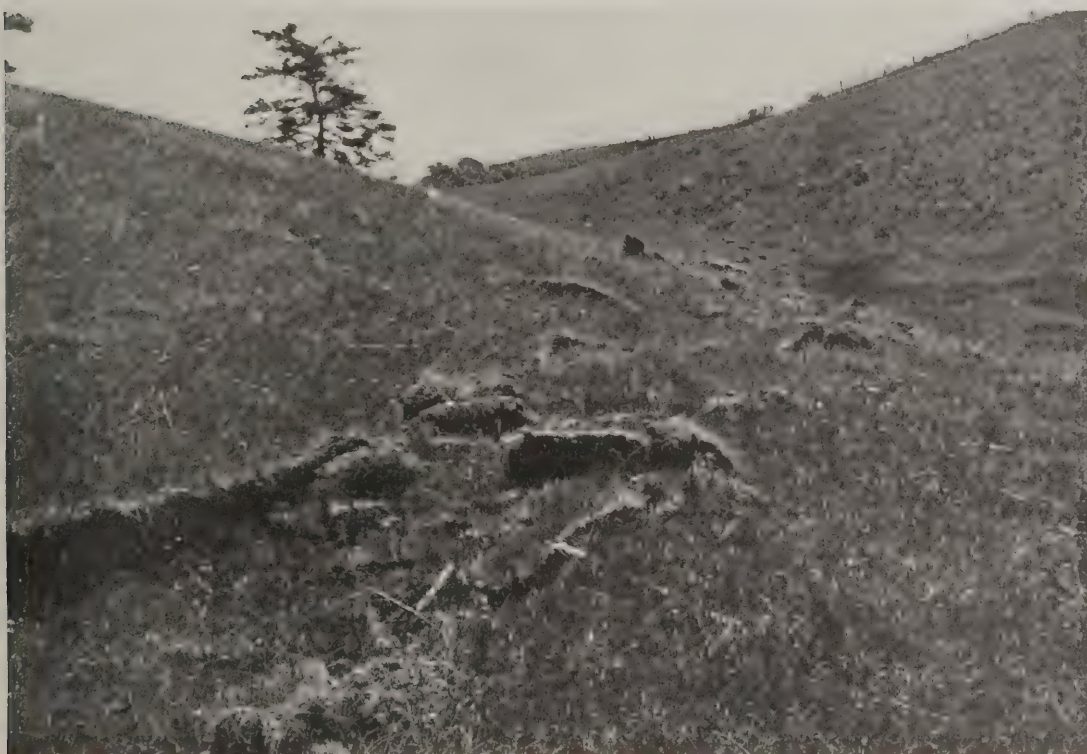
B. Fault-trace on grass-covered slope near Fort Ross. R. L. H.

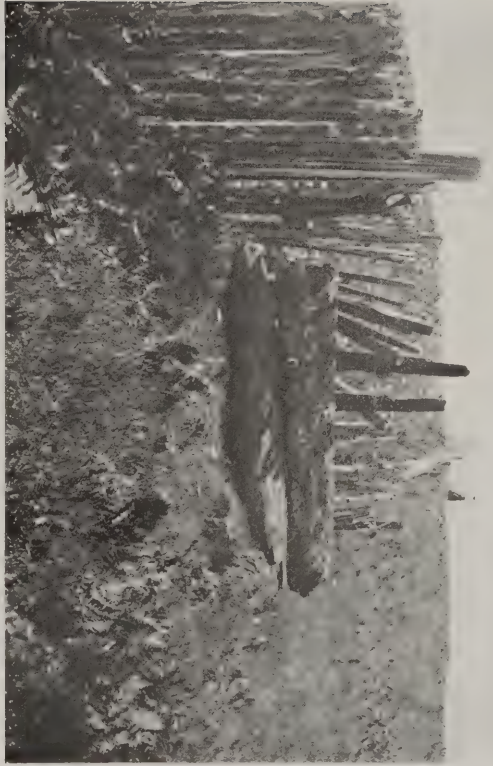
A. Offset of 8 feet on fence a mile east of Fort Ross, R. S. H.

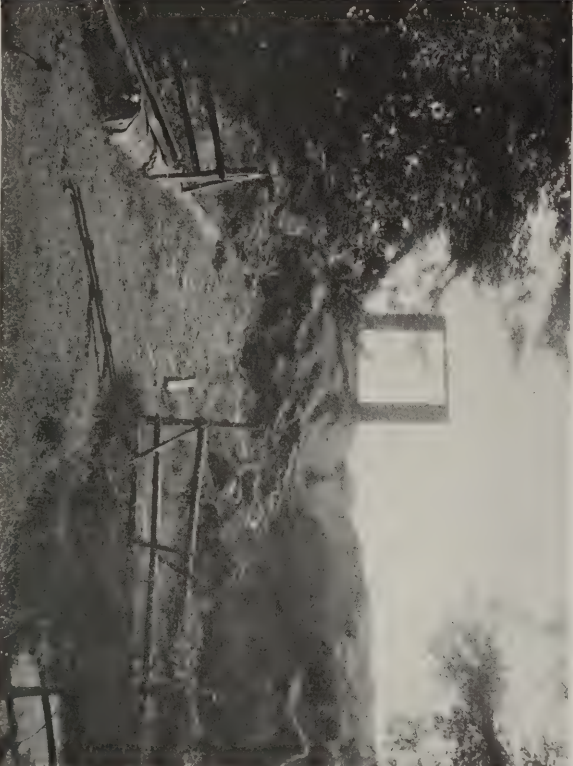
C. Roadway offset 12 feet. New fault-scarp 3 feet high, facing northeast. Above Fort Ross, F. E. M.

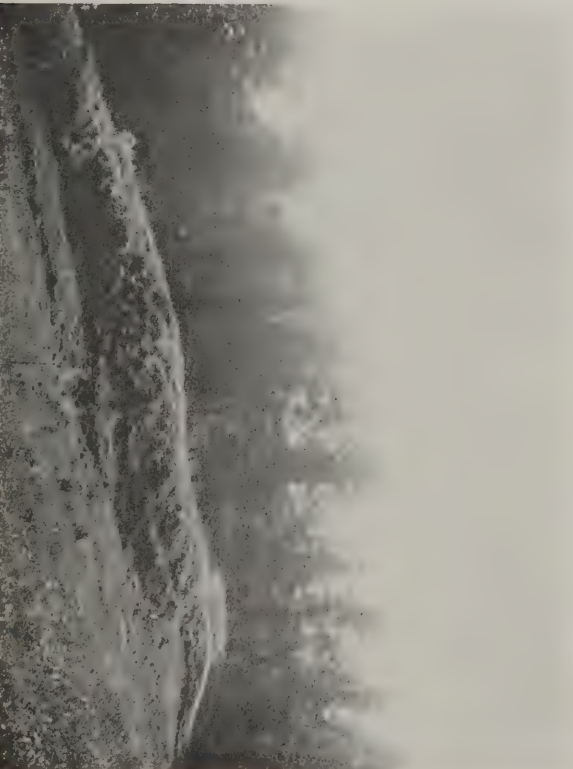
D. Accentuation of old fault-scarp by new fault. Near Fort Ross, F. E. M.

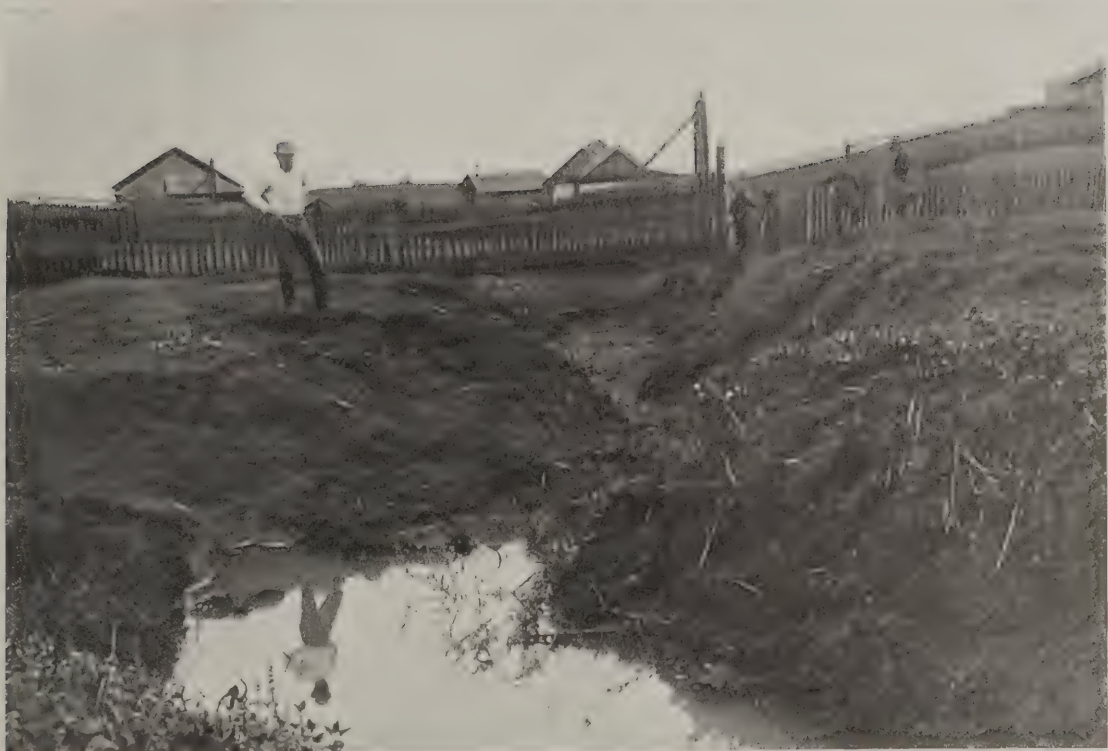
A. Offset of stream trench by the fault and ponding of water by the fault-scarp. Doda's ranch, a mile southeast of Fort Ross. A. C. L.

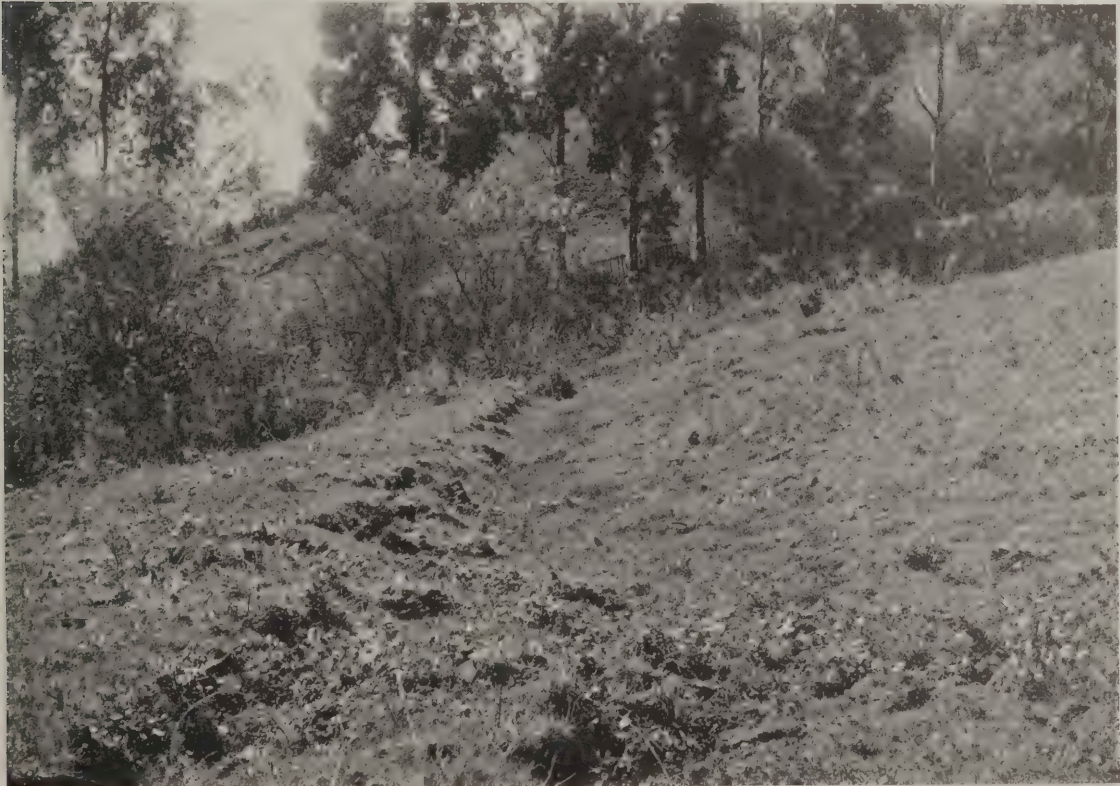
B. The fault-trace a mile northwest of Bolinas Lagoon, looking southwest. Illustrates the ridge phase. G. K. G.

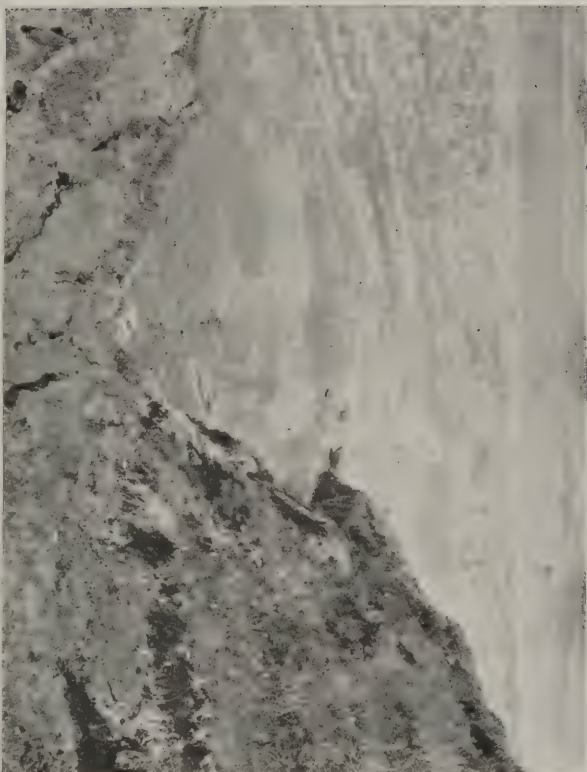
C. Fault-trace extending from cliff in foreground across tidal flats of Tomales Bay, near its mouth. R. S. H.

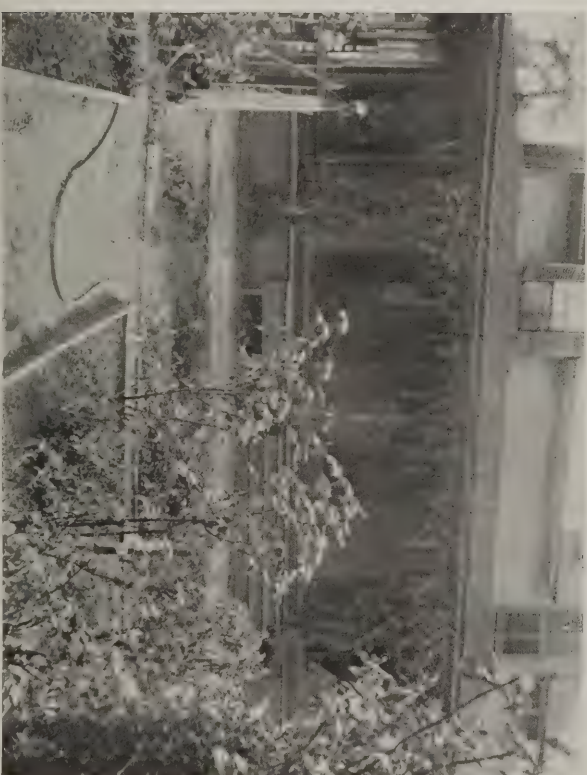
D. Fault-trace between garden and house, Skinner's ranch, near Olema. Before earthquake center lines of path and steps were coincident; afterwards offset was 15 feet 9 inches.

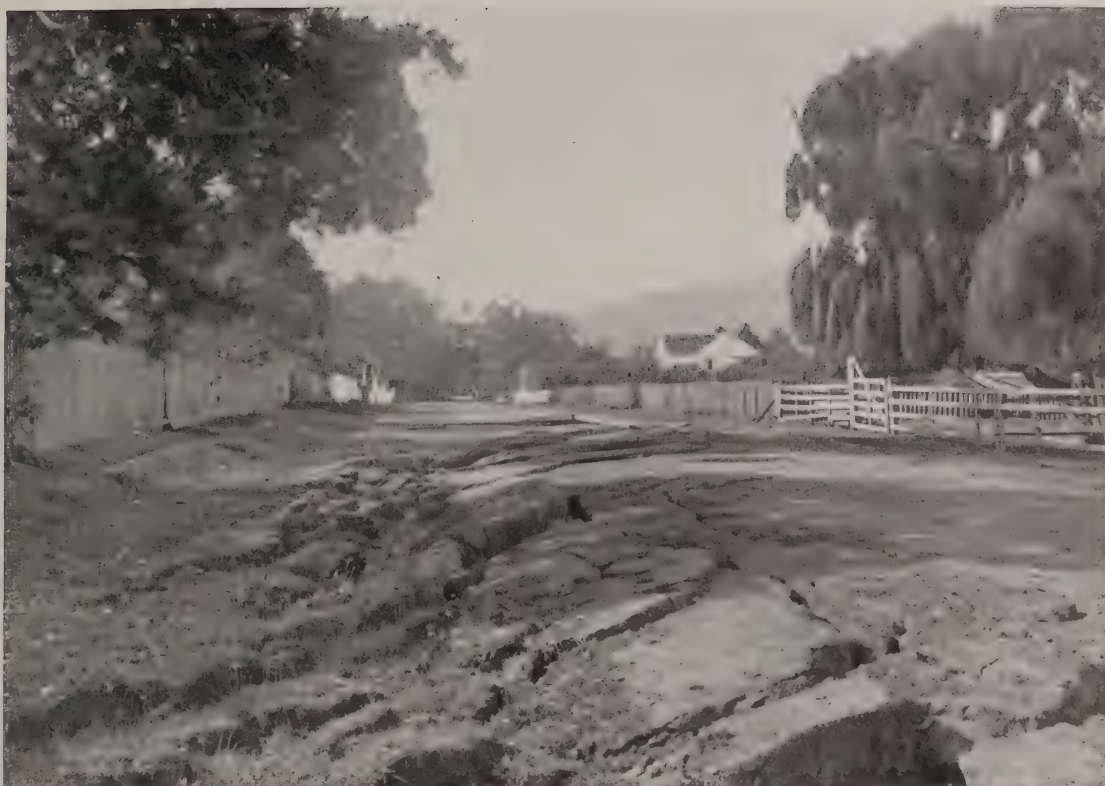
A. Branch of fault-trace in north part of Bolinas. Looking north-northwest. Illustrates diagonal cracks. G. K. G.

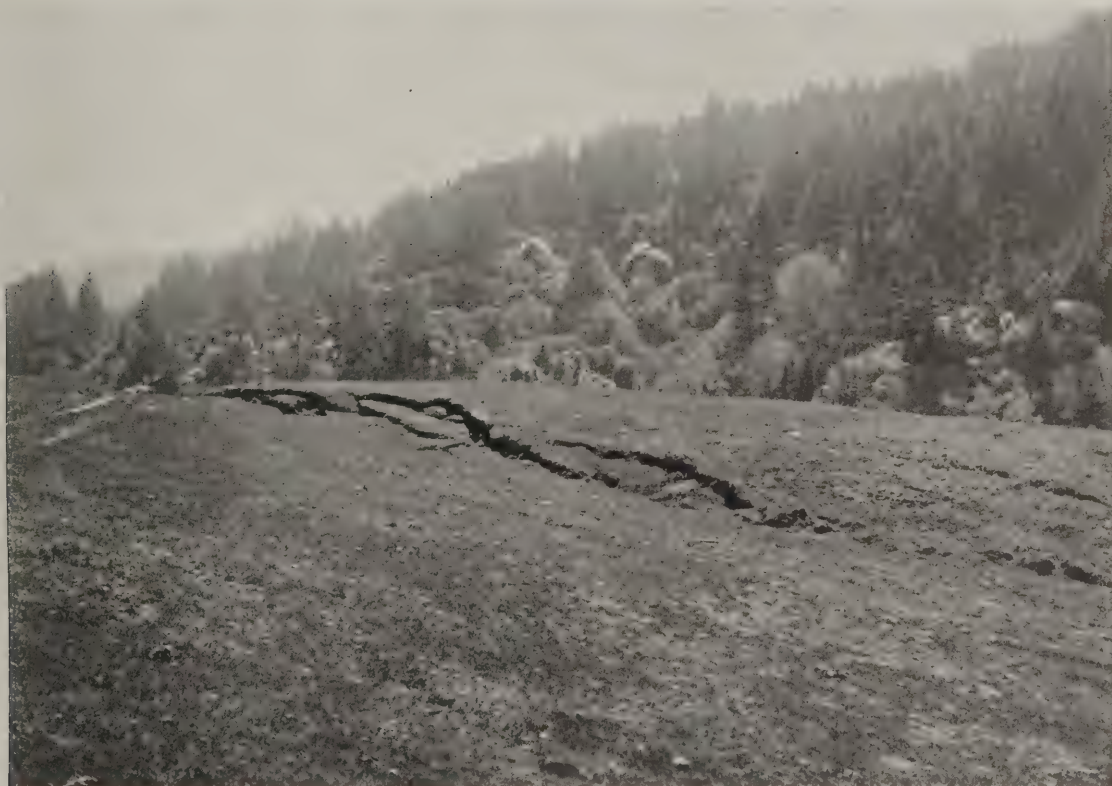
B. Branch of fault-trace, near Bondietti's ranch. Looking south. Illustrates diagonal cracks. G. K. G.

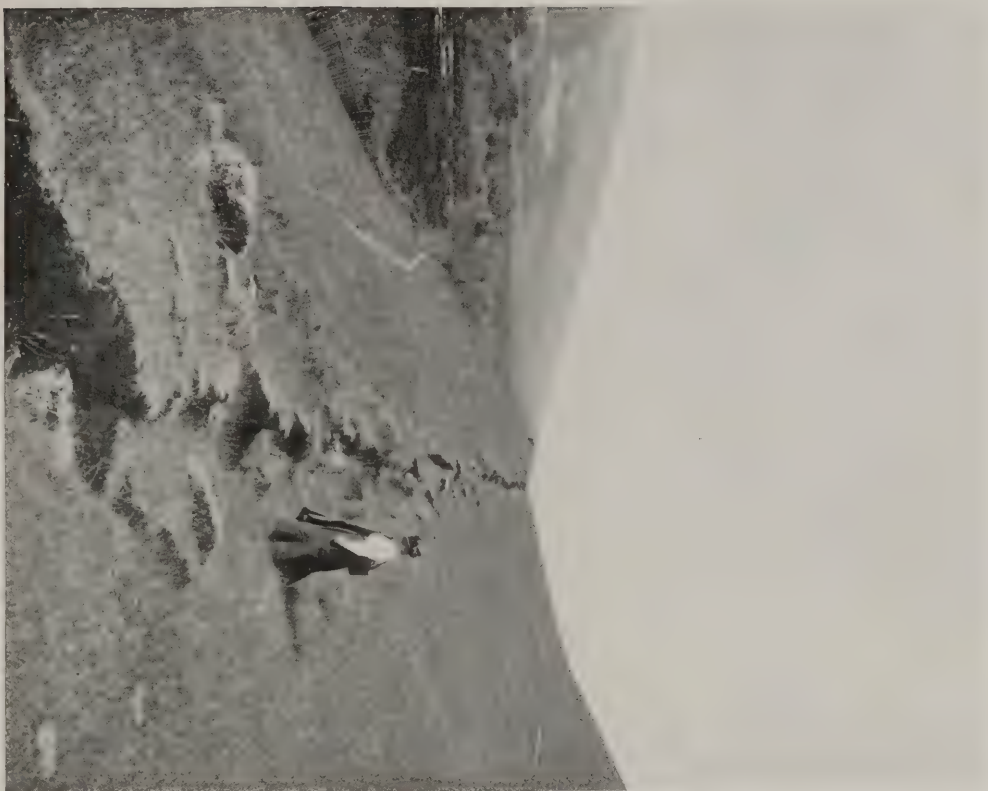
A. Fault-trace a mile northwest of Olema. Looking northwest. Illustrates ridge phase. G. K. G.

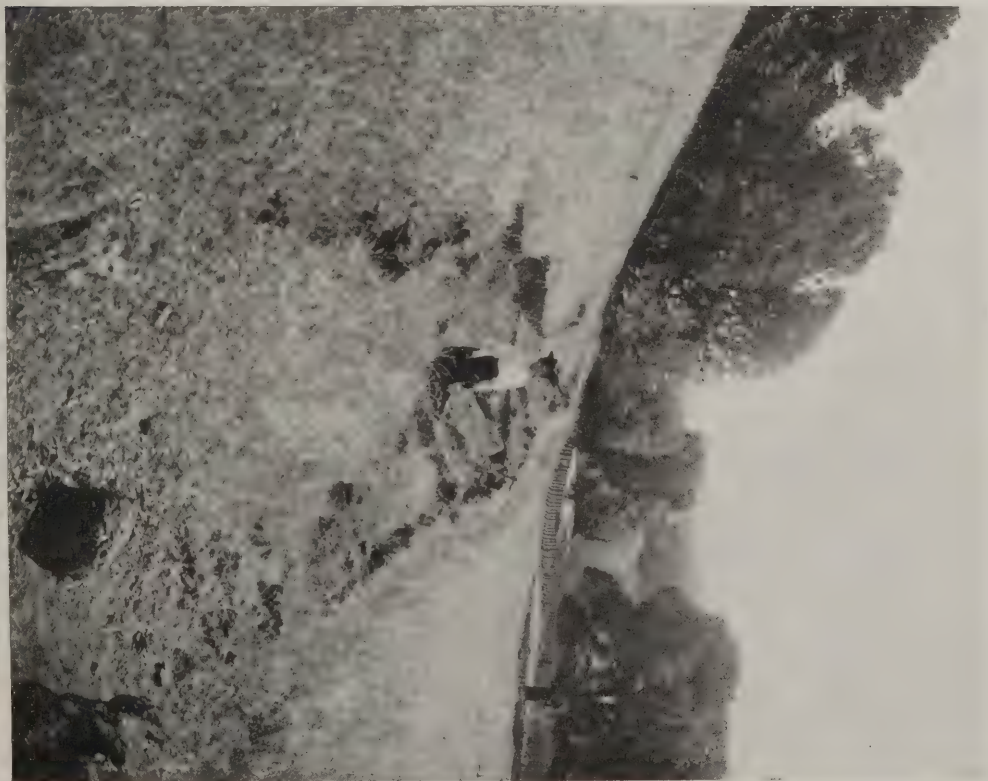
B. The fault-trace west of Olema. Looking southeast. Illustrates the trench phase. G. K. G.

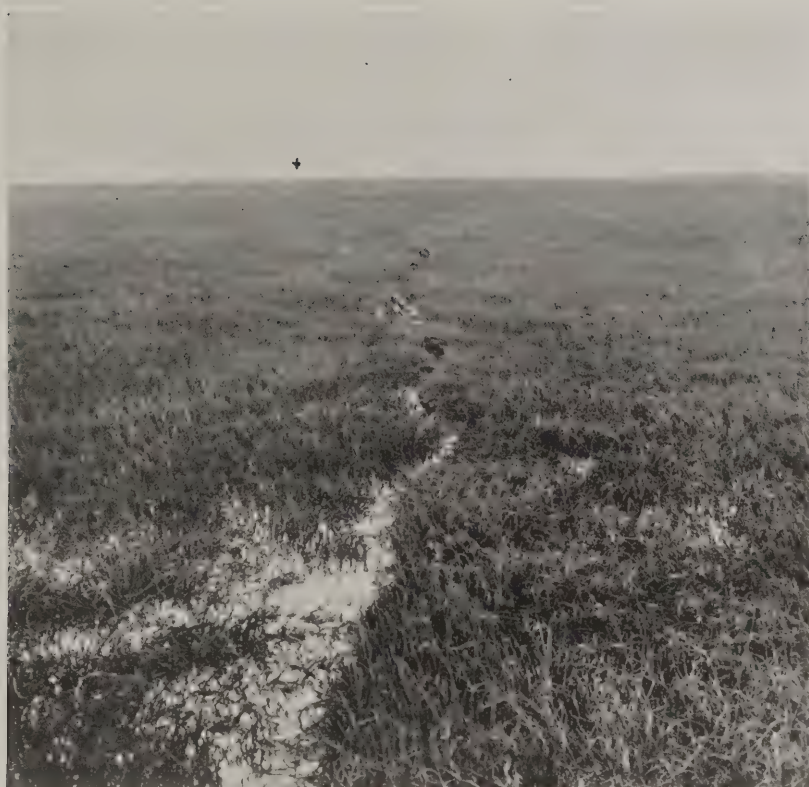
A. Looking southeast on Pepper Island. In the foreground the fault-trace is central. It trends toward the distant +. G. K. G.

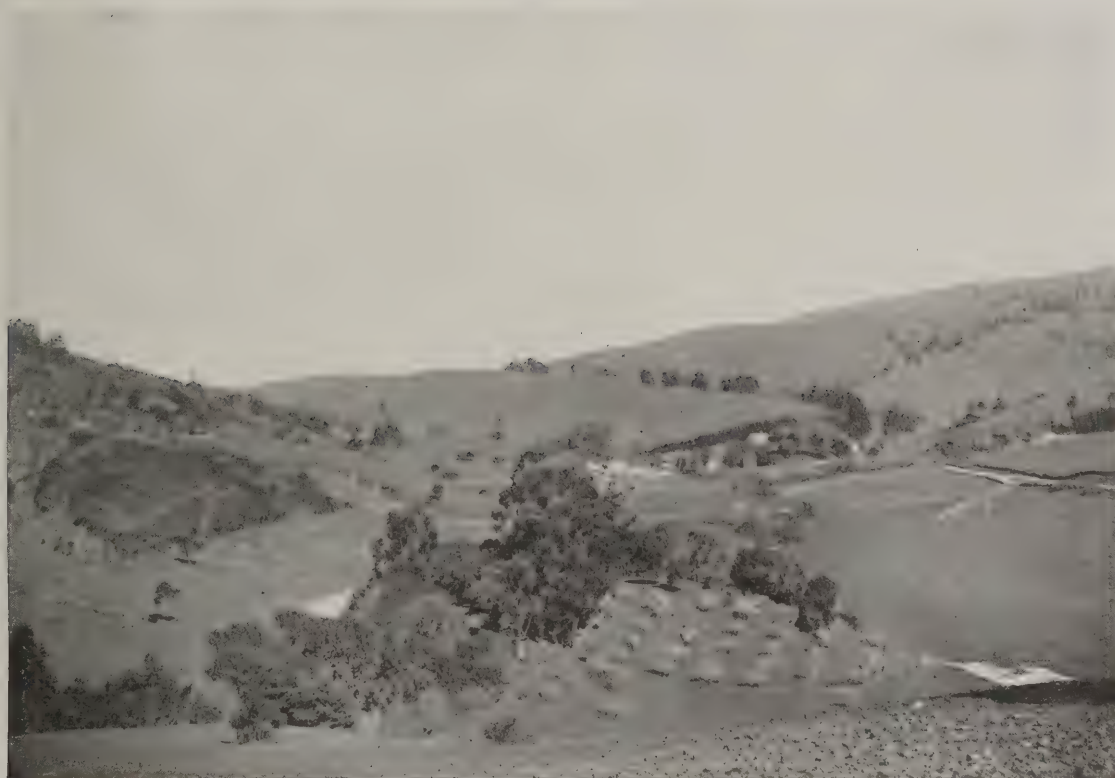
B. Looking north from hill west of Woodville. From buildings (Strain ranch) a large rift ridge runs northwest between 2 fault-sags. The western sag is followed by Pine Gulch Creek. Fault-trace runs from right of pond in foreground to left of buildings and follows sag for a mile, gradually crossing it. G. K. G.

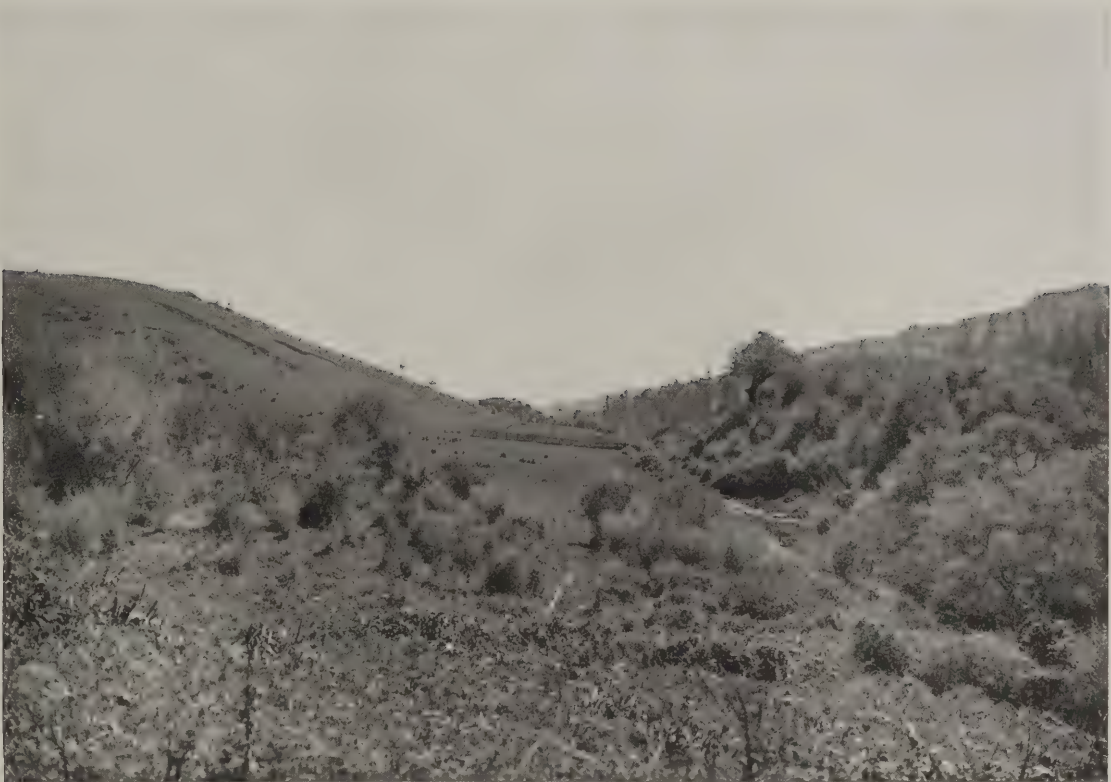
A. Sag followed by fault-trace a mile north of Strain ranch. Looking southeast. Trace, concealed by bushes, runs near ponds. G. K. G.

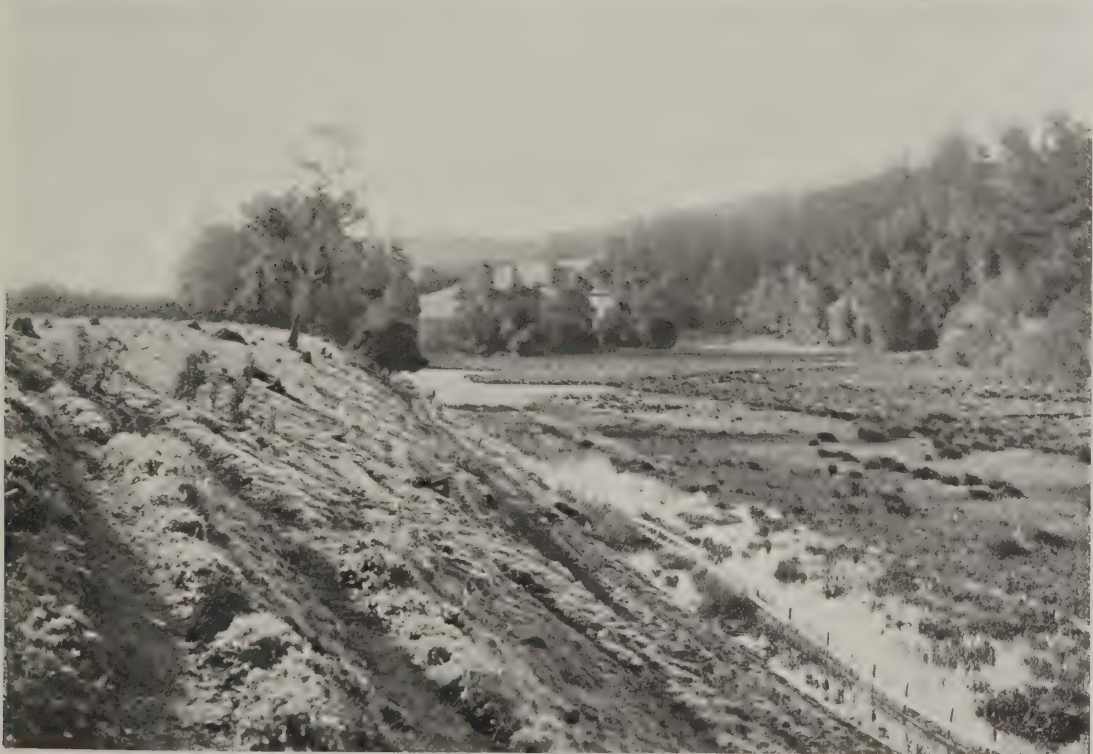
B. Looking southeast from point near Shafter's ranch, Olema. Fault-trace follows base of hill and includes water-filled depression. G. K. G.

plate 44.) A few minor branches were seen on the east side. The pool or lane of water shown in plate 42B is about 2 feet deep. Mr. Shafter states that the ground here was dry and under cultivation before the earthquake. Shortly after the shock he noticed that the current of a creek close by was reversed.

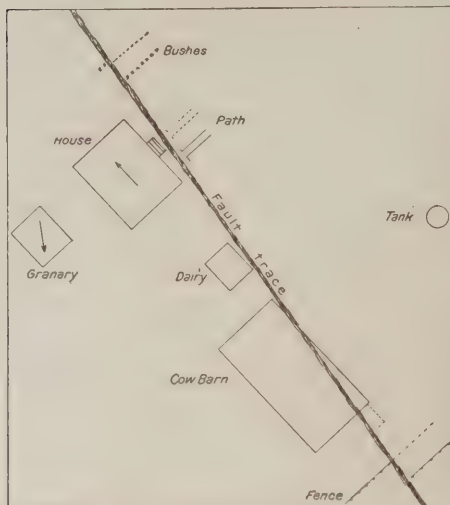
Eight miles farther north, at Mr. W. D. Skinner's place, near Olema, the entire fault is apparently concentrated in a single narrow zone, and the several measurements made are in close accord. The fence south of his barn (fig. 22) was offset 15.5 feet. The barn, beneath which the fault-trace past, remained attached to the foundation on the southwest side, but was broken from it on the northwest side and dragged 16 feet. A path in the garden, originally opposite steps leading to the porch, was offset 15 feet. (Plate 38D.) A row of raspberry bushes in the garden was offset 14.5 feet. The mean of these four measurements is 15.25 feet, and their range is 1.5 feet.

FIG. 22. — Plan of Skinner premises, showing character of displacements measured. The broken lines show positions of bushes, path, and fence before earthquake in relation to objects west of fault; also position before earthquake of corner of barn with reference to ground east of fault.

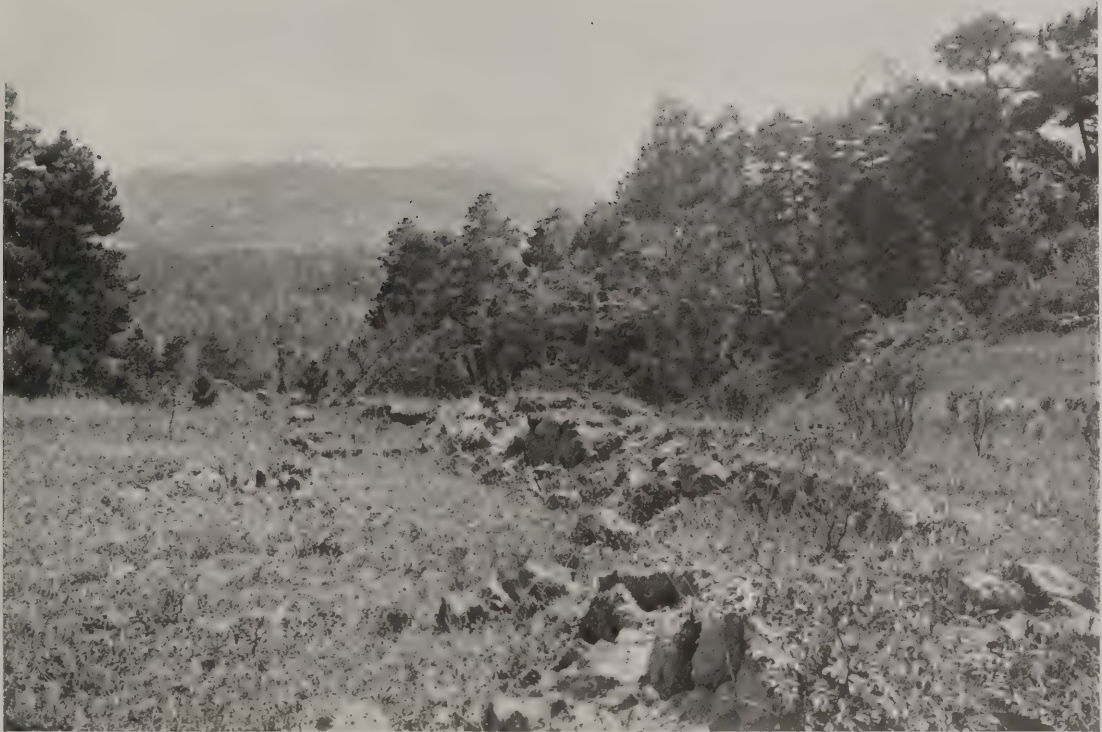
B. Road offset by fault. Looking southwest. G. K. G.

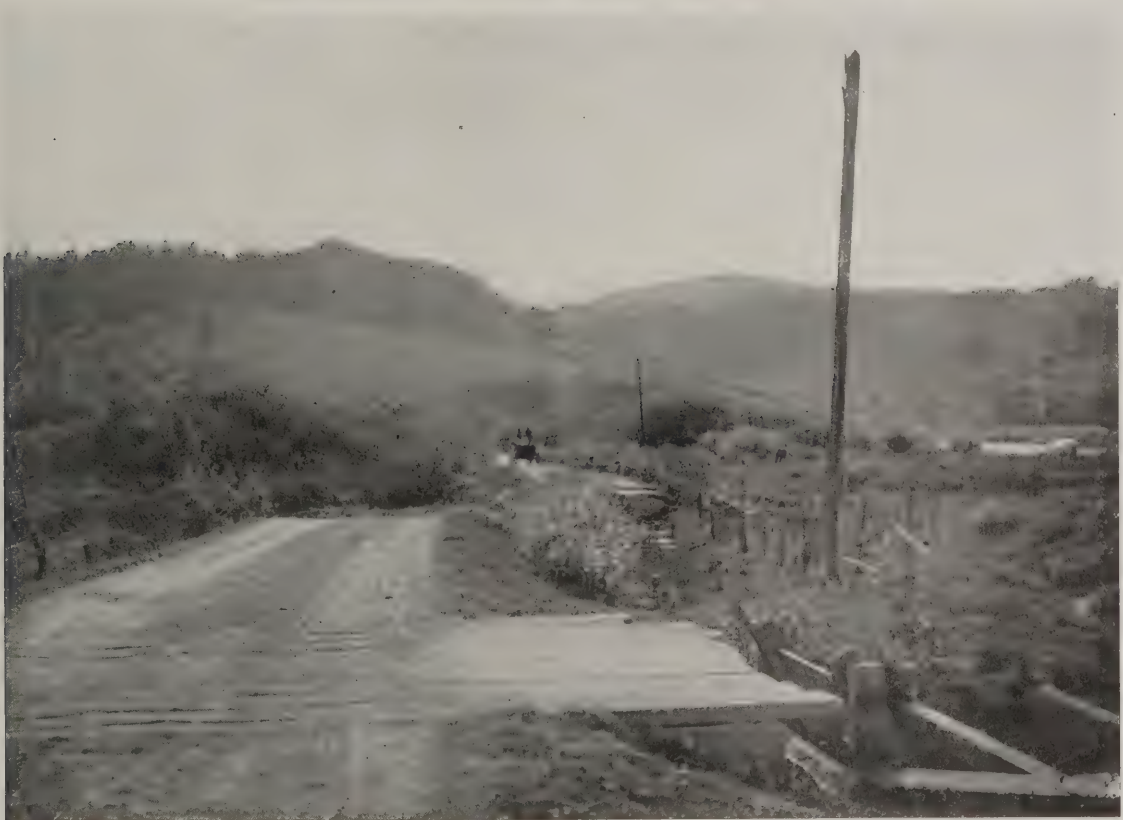
the northwest the horizontal throw caused an apparent vertical downthrow to the northeast. (Plate 48A.) Where the ground sloped toward the southeast an apparent vertical throw to the southwest was produced. Where the fault-trace followed a narrow sag interrupting the side slope of a ridge, the apparent vertical throw was on the side toward the ridge, as indicated in the diagram, fig. 6. (See also plates 10B and 48B.) The only unqualified record of vertical displacement is on Pepper Island in Bolinas Lagoon, where the mean of seven measurements shows a downthrow of 12 inches on the northeast side. The question whether the faulting along the plane of rupture was accompanied by the elevation or depression of large areas will be discussed in another place.

A. Fault-trace a mile northwest of Olema. Looking south. Appearance of vertical displacement largely due to combination of horizontal displacement with slope of ground. G. K. G.

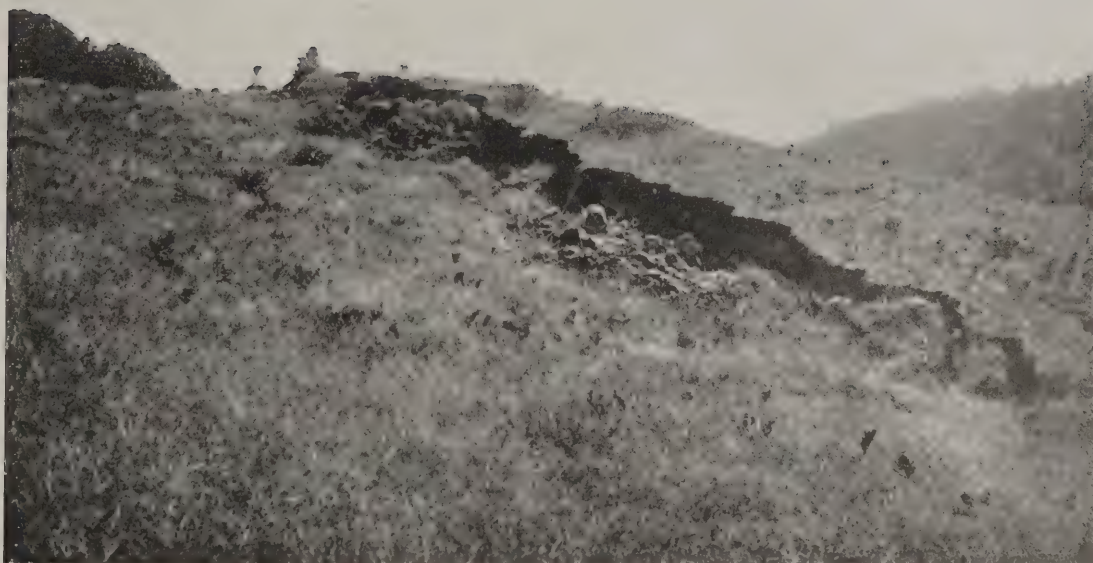
B. Fault-trace near Bondietti's ranch. Looking southwest. Shows vertical displacement bordering a sag. Horizontal displacement shown by fence, which had been repaired. G. K. G.

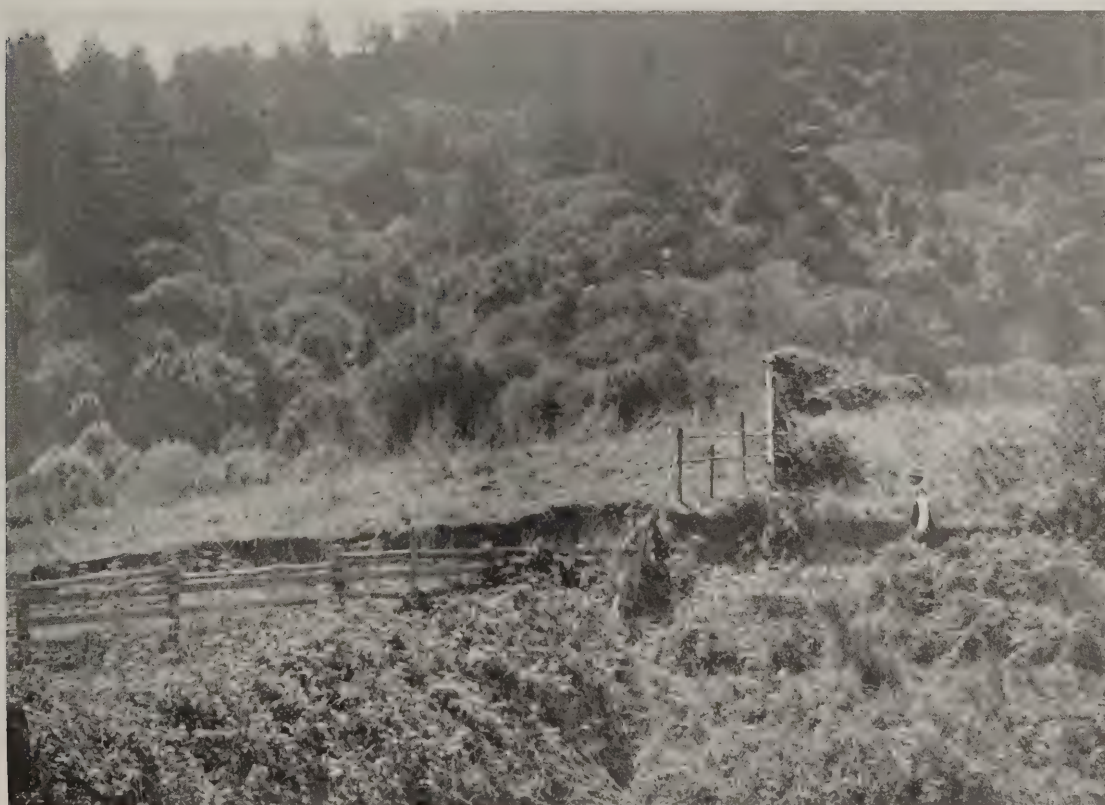
A. Fence offset by fault. Looking northwest. Camera was aimed with straight part of fence beyond the disturbance, to bring out flexure as well as offset of fence. G. K. G.

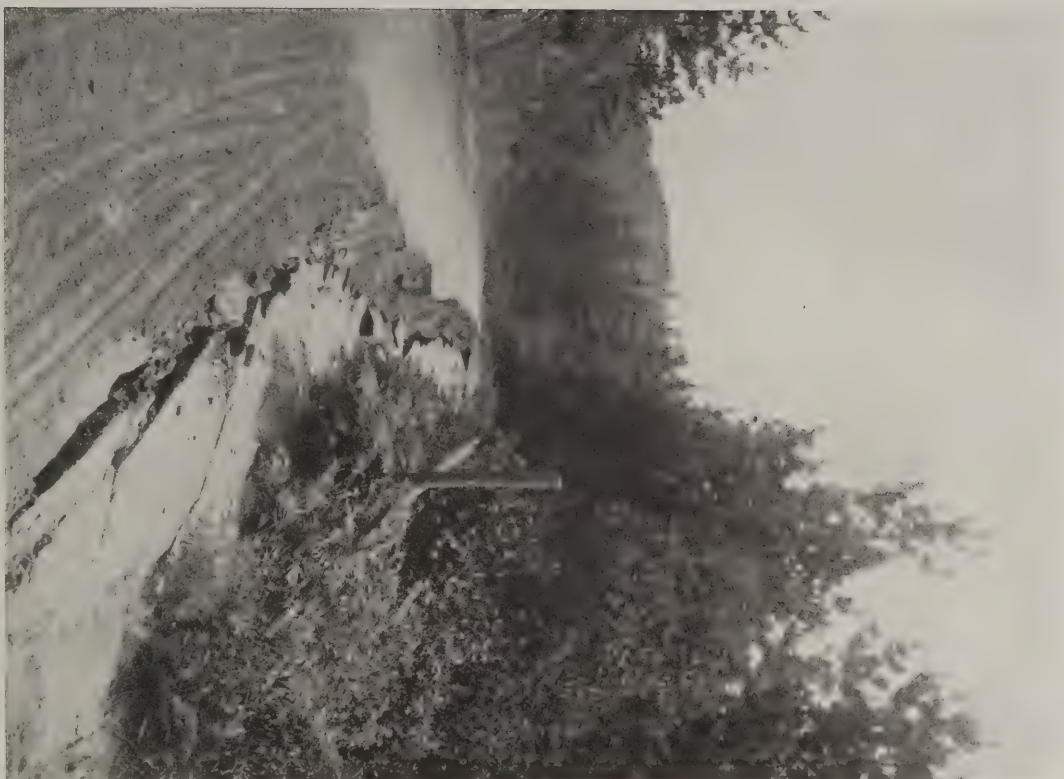
B. Roadside crack a mile southeast of Inverness. G. K. G.

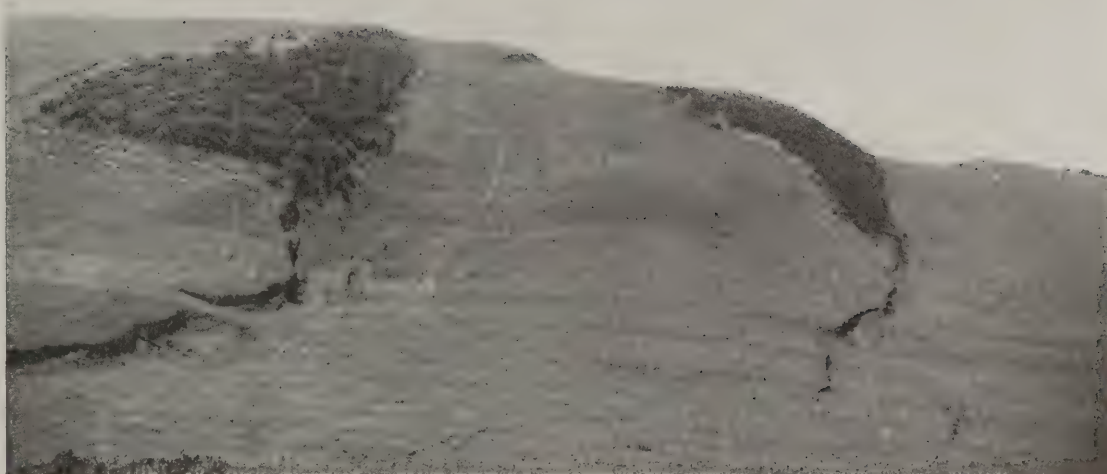
B. Earthquake cracks in Bolinas at edge of an earthquake sag. G. K. G.

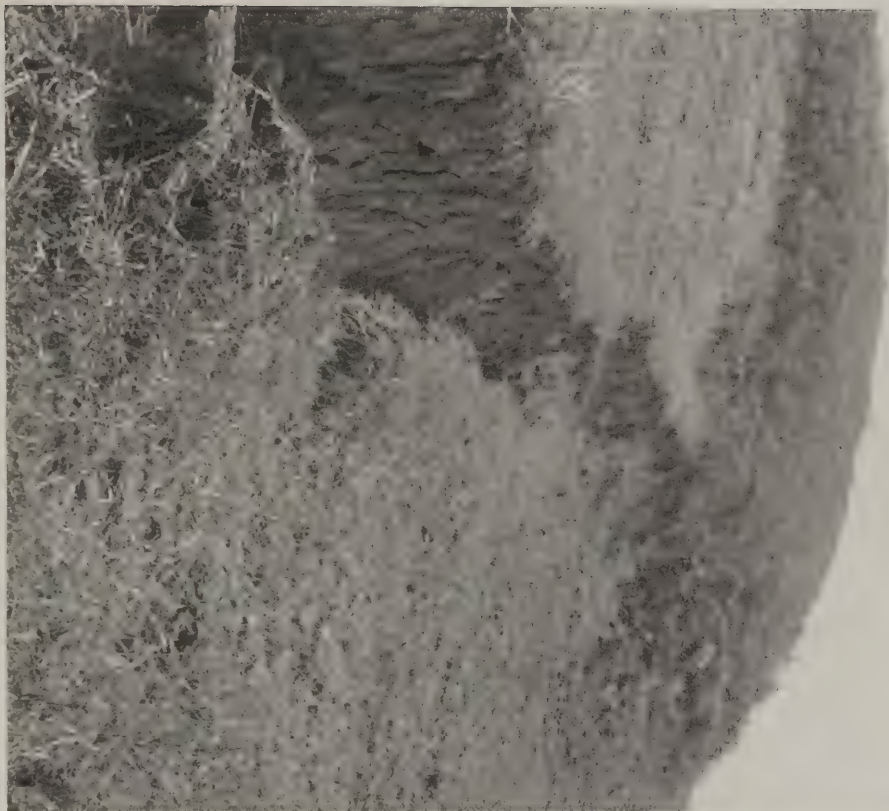
B. Landslide from road-cliff about two miles west of Inverness. Slide occurred at time of earthquake. G. K. G.

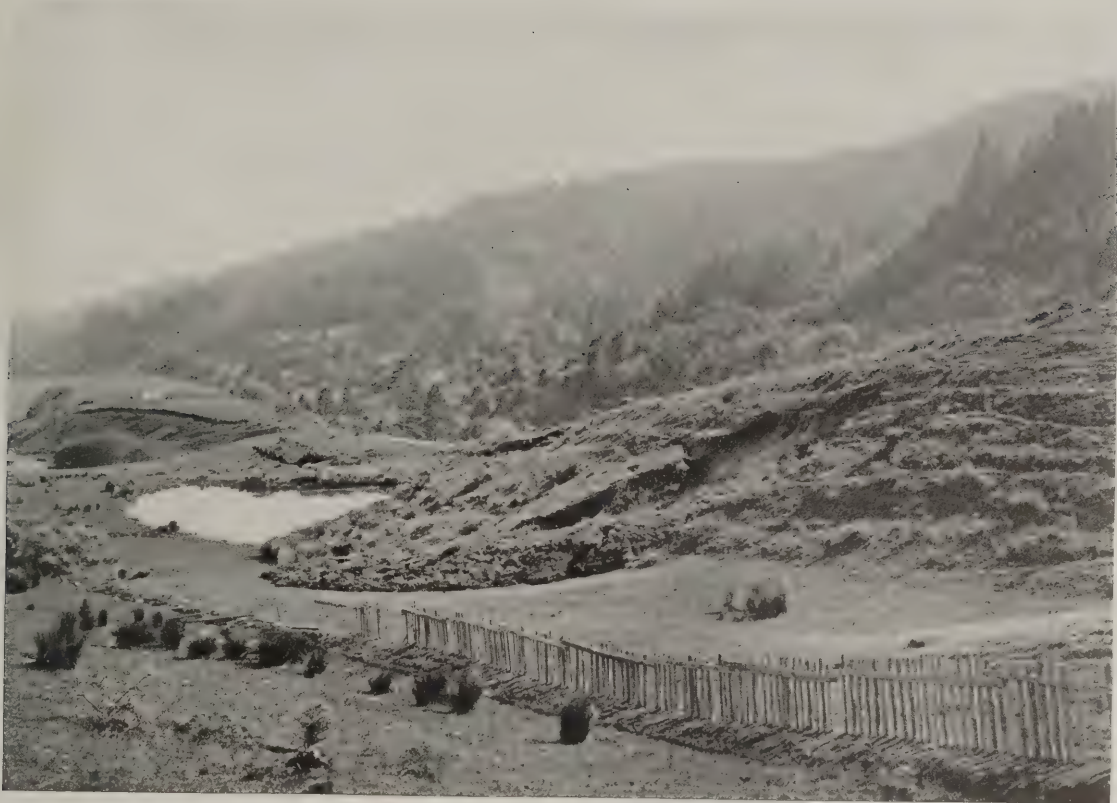
When the tidal mud was first seen after the earthquake, it was observed to be covered with ridges and troughs. (Plate 54B.) This corrugation was gradually smoothed out by the action of the waves (plates 55B and 56A), so that at the expiration of a year its expression was largely lost, tho a few of the larger ridges could still be traced, and much of the plain retained a pattern imprest on it by the ridging. It is probable that the entire tract of tidal mud was thus affected, altho the ridges were not seen on the area lying nearest to the east shore. That area did not come under observation until after the spring floods

B. Ridged mud plain 1 mile from Inverness. Looking east-southeast. Mr. Hamilton's barn at right. April 28, 1906. Tide is low. Pools occupy the deeper troughs. G. K. G.
